Refurbishment

Case study

Feniscowles School Blackburn

Lessons in roofing

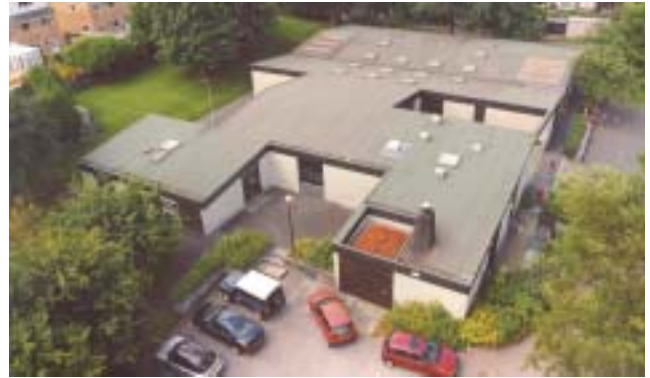
Before

When the felt roof on Feniscowles School in Blackburn reached the end of its useful working life, overcladding with a curved standing-seam roof in Colorcoat HPS200® provided the solution. The flat roof was in need of refurbishment, but was structurally sound so clients, Blackburn with Darwen Borough Council in conjunction with the Capita Group, decided to over-roof it rather than opt for a full replacement. A lightweight curved rafter conversion system was fixed directly to the roof deck which created a roof with a single curve. Existing

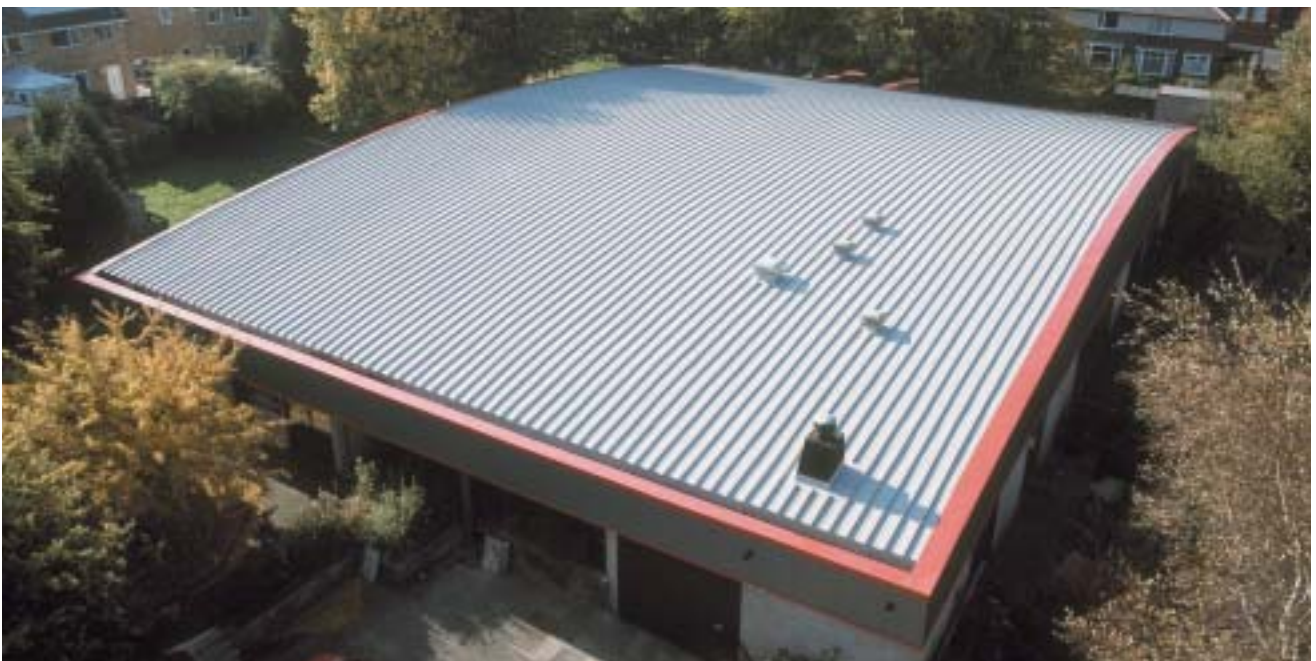
After

valleys were thus eliminated, allowing drainage to be moved to the outside of the building. The system also allowed the thermal performance of the roof to be upgraded to 0.25 W/m²K in line with current Building Regulations. Finally, the contractors extended the roof space across the quadrant area creating more classrooms for the school. This was an added bonus as this feature used up a large amount of previously wasted space.

All components were available and ready for installation when required, with no waiting on secondary trades or delayed deliveries. This also included the flashings which were selected in Petra *Colorcoat HPS200* to provide a visual contrast. The project was timed to eliminate any disruption to the day to day running of the school and was completed in the six week period over the summer school holiday.
